SA Project File 111-12-002

**Re: Report of Initial Study of Alternatives
Old Mill Pond Dam, State ID No. 105.03
Hampton, New Hampshire**

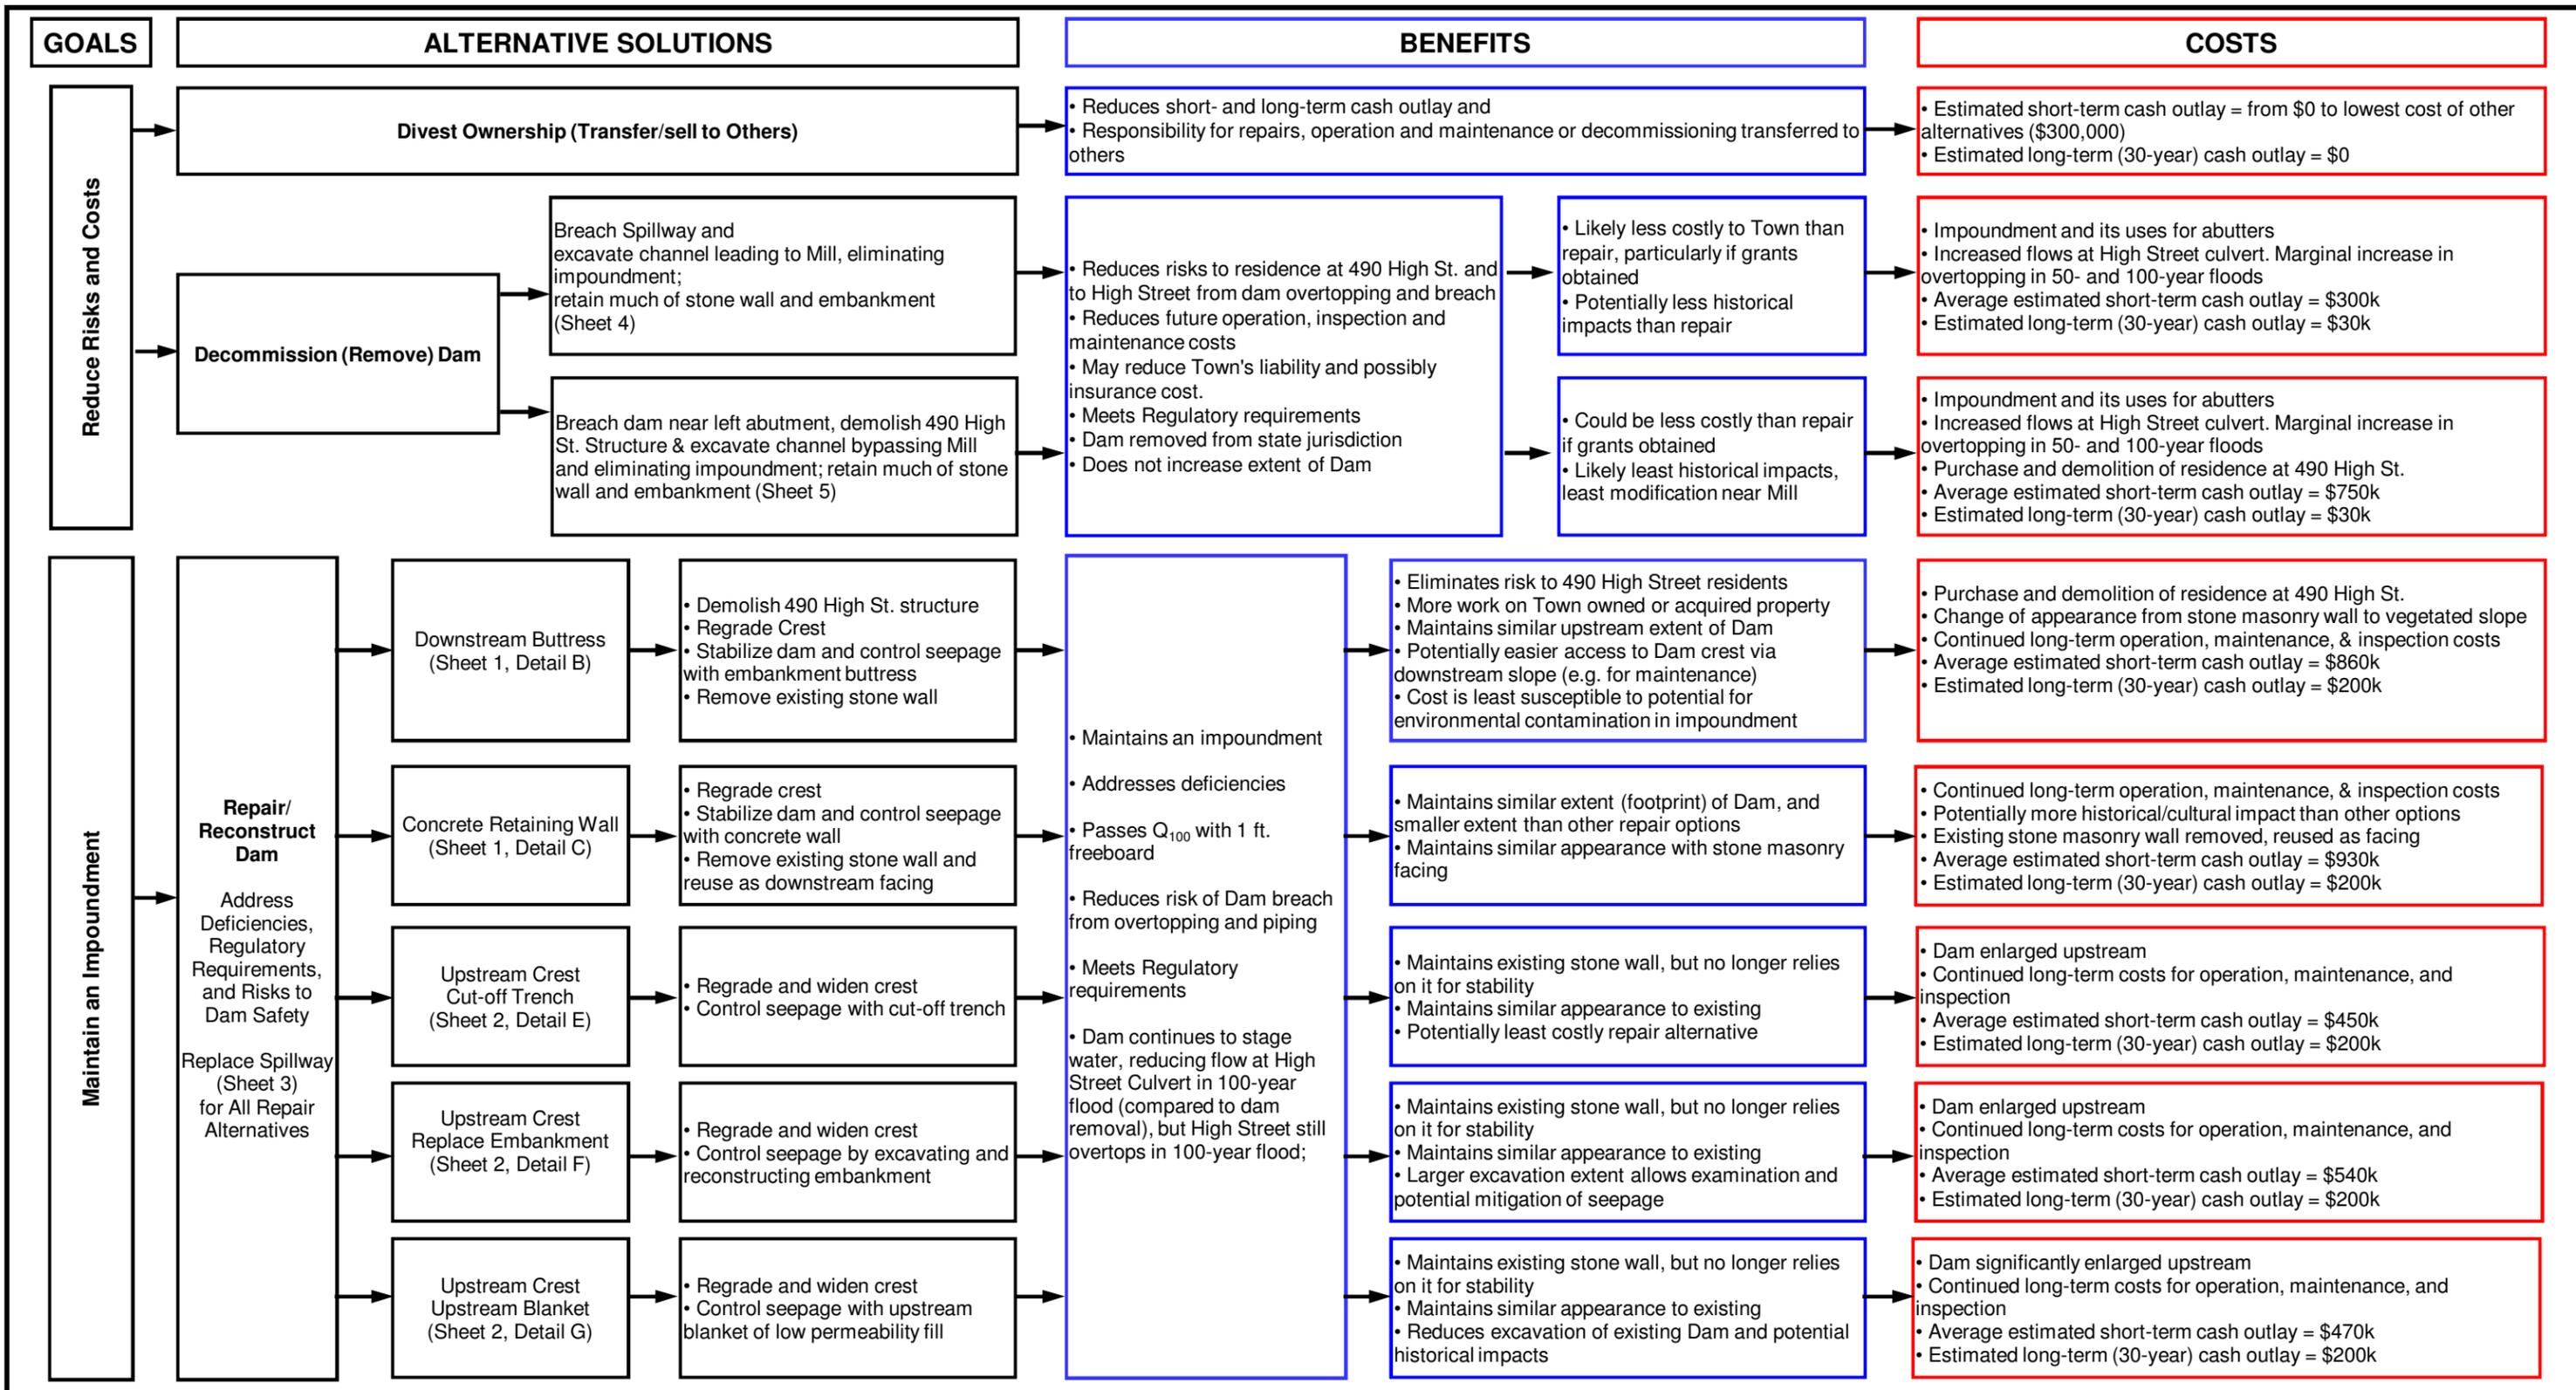
NOTES: The purpose of this Decision Tree is to aid the Town in understanding and evaluating Conceptual Options related to Old Mill Pond Dam. This Decision Tree should be considered in conjunction with SA's Report of Initial Study of Alternatives. Estimated costs for design, permitting and construction. Estimated costs are based on conceptual designs and are intended to provide order-of-magnitude costs for qualitative comparison of alternatives and are in today's dollars (2013).
